UPDATES TO THE WAYNE COUNTY COURTHOUSE

LAST UPDATE: January 22, 2016 Update

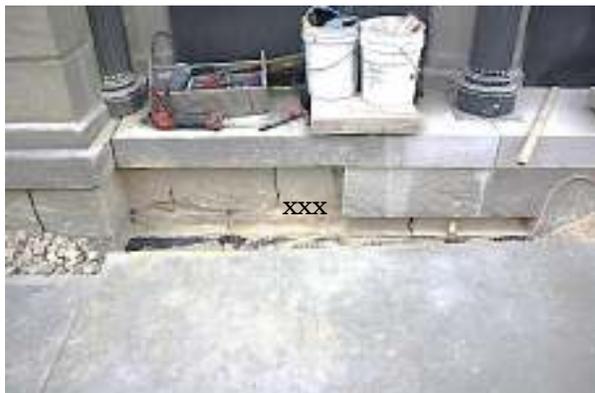
Stone removed for Dutchmen repair

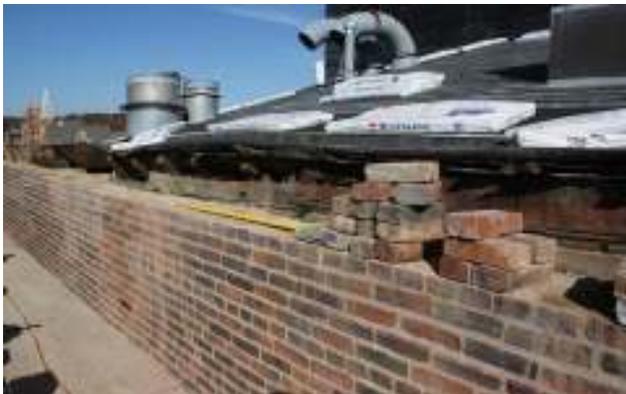
Typical condition of exposed mortar along the wall

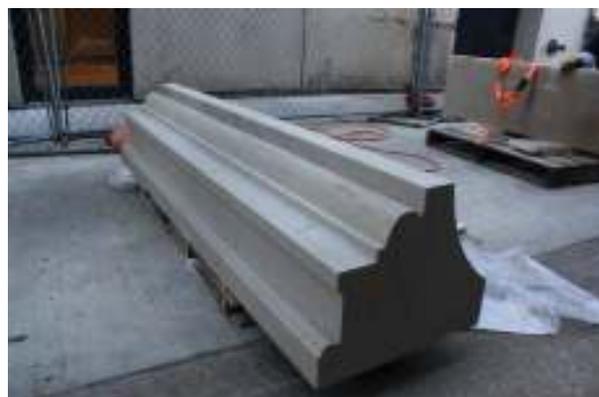
New hip roll installed
on the Clock Tower

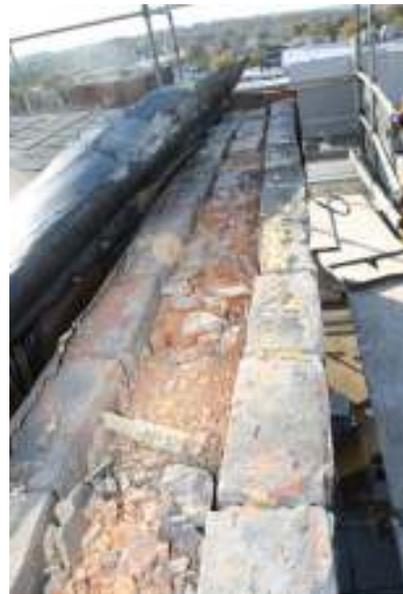
General condition of masonry
under the existing parapet cap
on the west side of the Courthouse

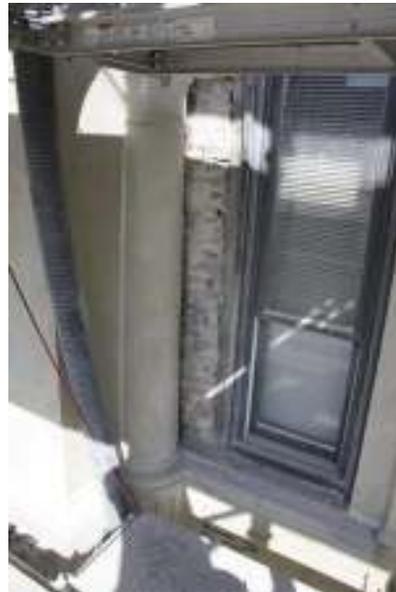
Stone removed for Dutchmen repair

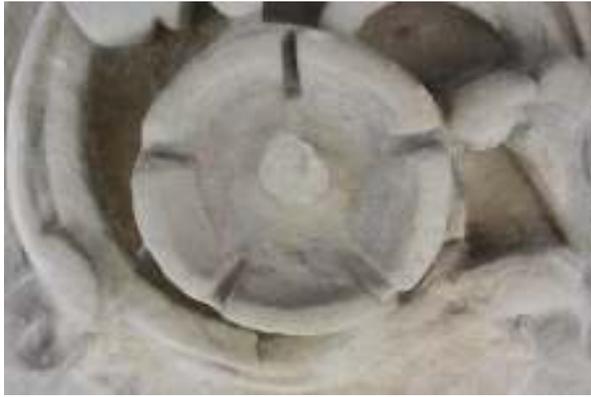
WR Restoration did a fantastic job matching the crack injection material to the existing stone

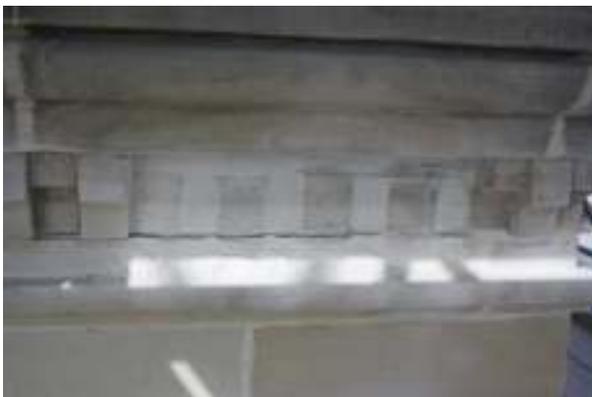
Deteriorated stone dentils removed to facilitate the installation of new stone

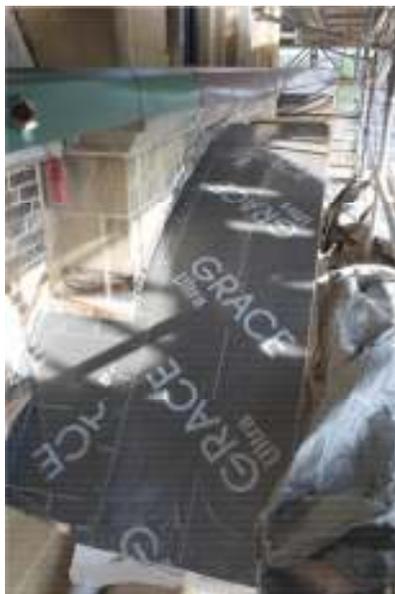
New sheathing and ice and water shield installed on the barreled pediment roofs located on the east face of the Courthouse

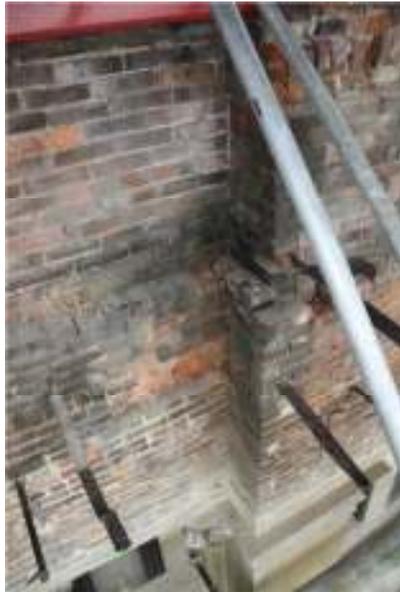
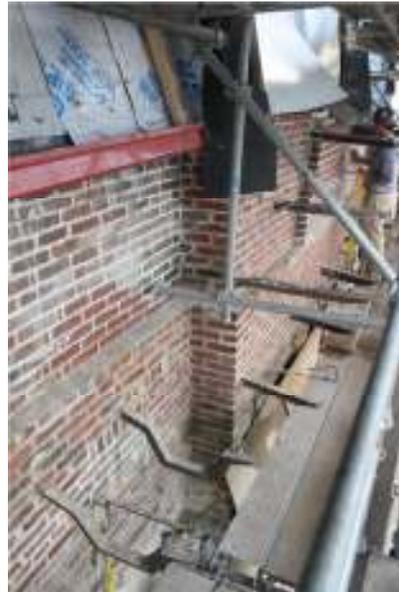
Brick repair on the south face of the Courthouse
Left picture is BEFORE; Right picture is AFTER

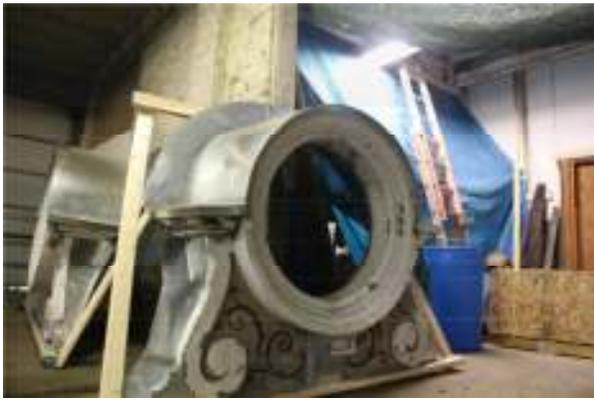
ASM barrel dormer that has been structurally stabilized. The paint will be stripped and then further repairs will be made.

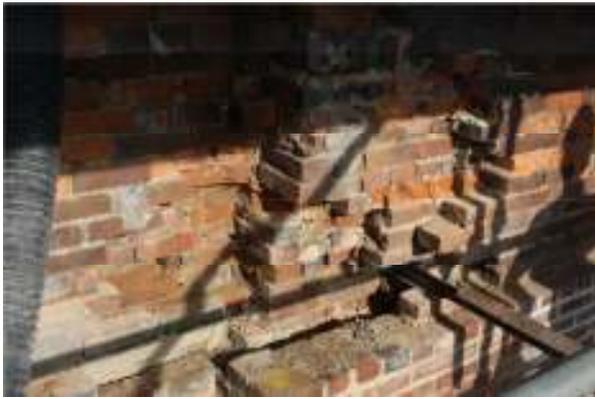
Damaged brick wall in the process of being repaired. This brick wall was located behind ASM panels and was an unforeseen condition

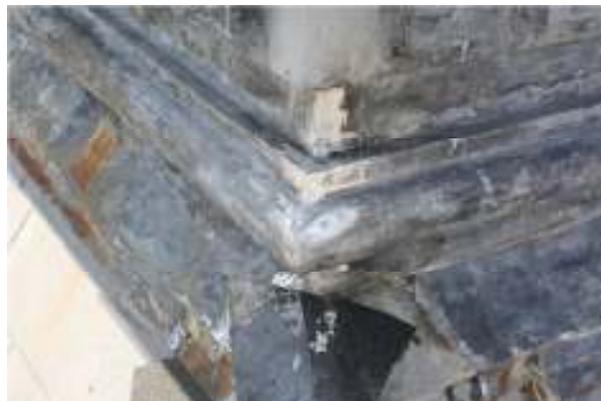
ASM miter joint repaired with new solder

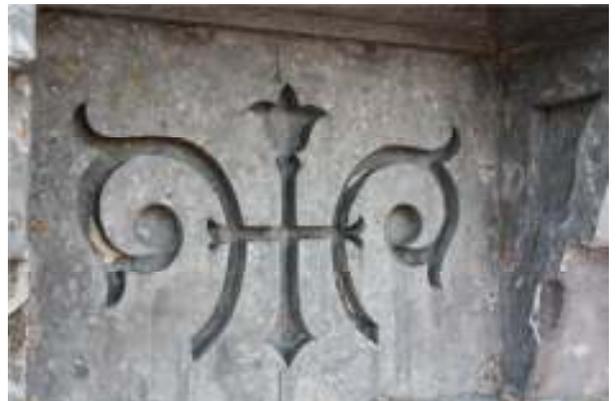
ASM panel reinforced from the inside with new sheet metal

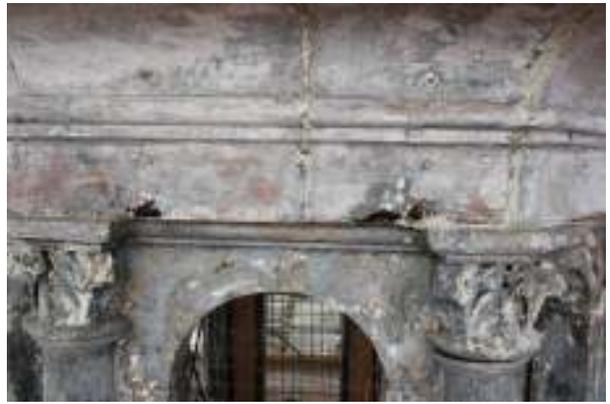
Paint Removal and Deteriorated Metal
on the Clock Tower Cupola

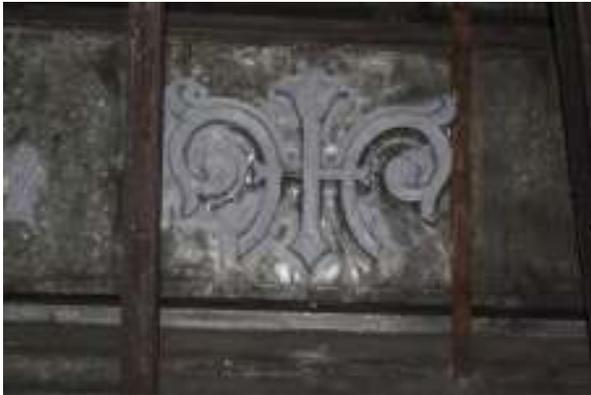
Repairs made to ASM Panels from inside the Courthouse Attic; ASM is being repaired from the inside prior to paint removal to prevent the scrollwork from falling apart

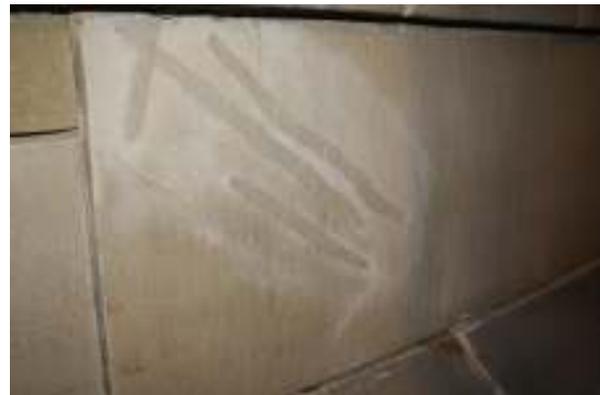
Stone Cracks injected with Epoxy.
The light haze around the cracks is dust.

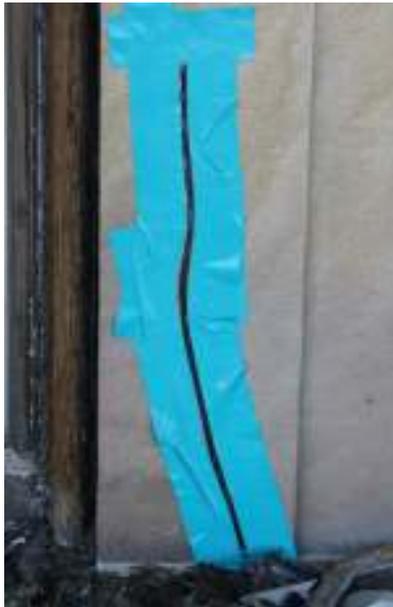
Stone Crack injected for Bonstone crack injection epoxy
